TREADWAY

NOVEMBER 2010

SHERMAN FALLS BRIDGE REPLACED AFTER 25 YEARS OF SERVICE

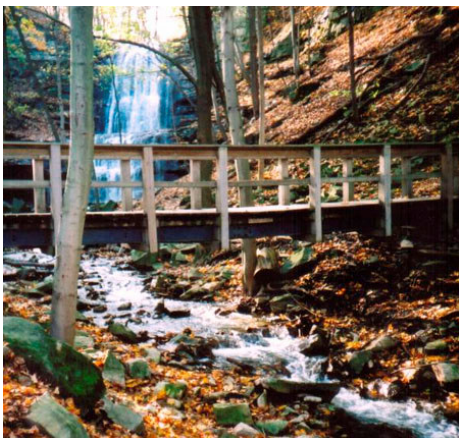
The Sherman Falls bridge has been a landmark for over 25 years. Not only has it served as a viewing platform for one of the most spectacular waterfalls in Ontario, it has also facilitated safe passage for thousands of hikers along the Bruce Trail. It's also a favourite prop for hundreds of wedding pictures. On any one day the bridge and falls receives dozens of visitors.

The bridge was originally built in the '80s by volunteers and with a generous donation from Stelco

who provided the steel beams. The beams were assembled in 4 sections and bolted together. Over the years, wear and tear

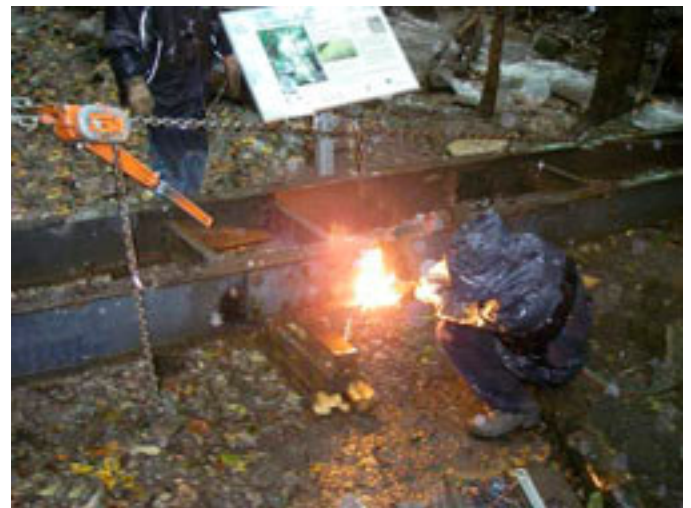
has taken its toll. It was time to replace the bridge. Through the gallant efforts of our volunteers, a generous donation from *Siemens Fossil Power Generation, Hamilton*, the permission of the landowner, and some help from Hamilton Conservation (talk about a team effort) the project was underway.

The trail was rerouted temporarily to allow safe passage for hikers around the construction area. The old bridge was dismantled. The railings and deck boards were removed and the discarded lumber was piled neatly to one side. Some of the salvaged lumber will be used again on future projects. The exposed steel beams weighing 1400 pounds, were carefully

lowered into the streambed using cables and people power. Once on the ground, the beams were cut up into manageable pieces and carried to the nearby roadside to be salvaged.
